**TRANSPORTATION RESEARCH CENTER**

**ON-SITE SCHOOL BUS INVESTIGATION**

**CASE NO. - 92-10  
FLEET - PRIVATE VEHICLE  
LOCATION -  
ACCIDENT DATE - 1992**

**TRC/IU CASE NO. 92-10**

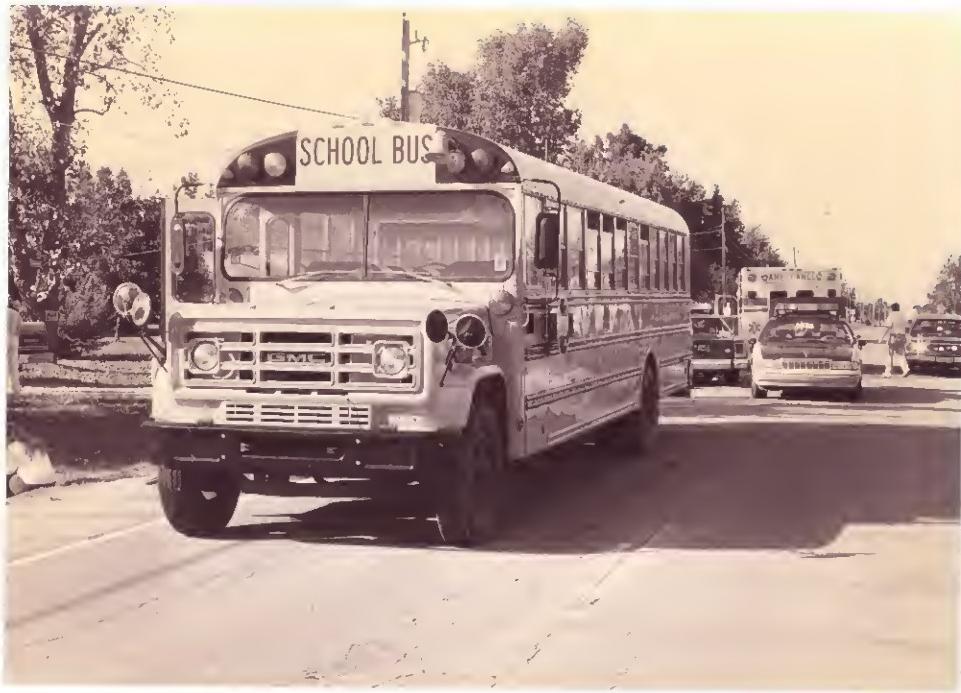
# 01 --

TRC/IU: 92-10, Task: 0085  
MCSD-Front & right & victim

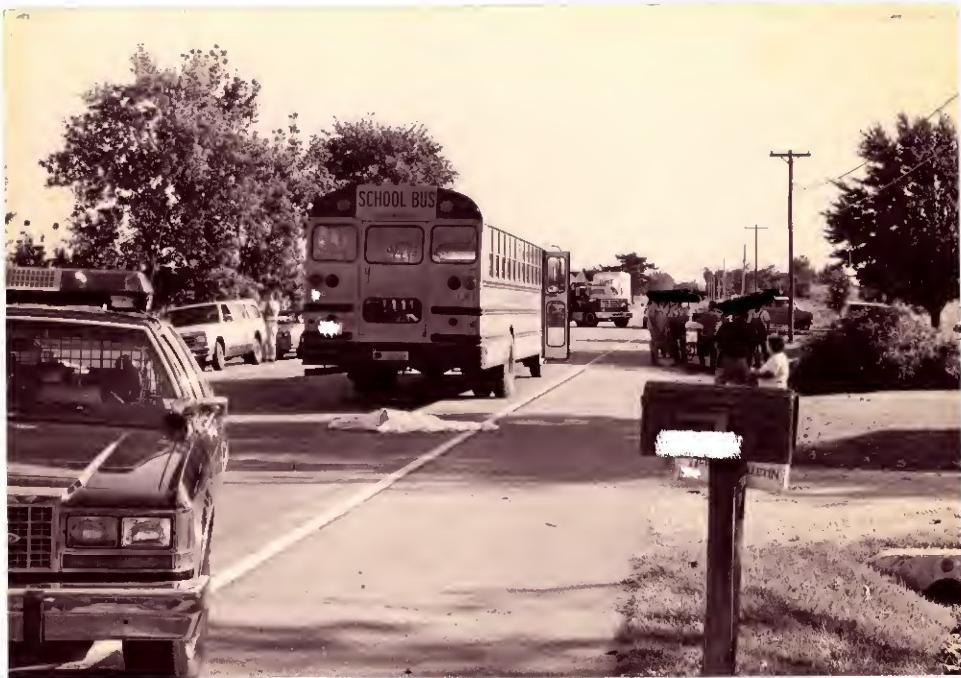
# 03 --

TRC/IU: 92-10, Task: 0085  
MCSD-Rear & victim & R tires

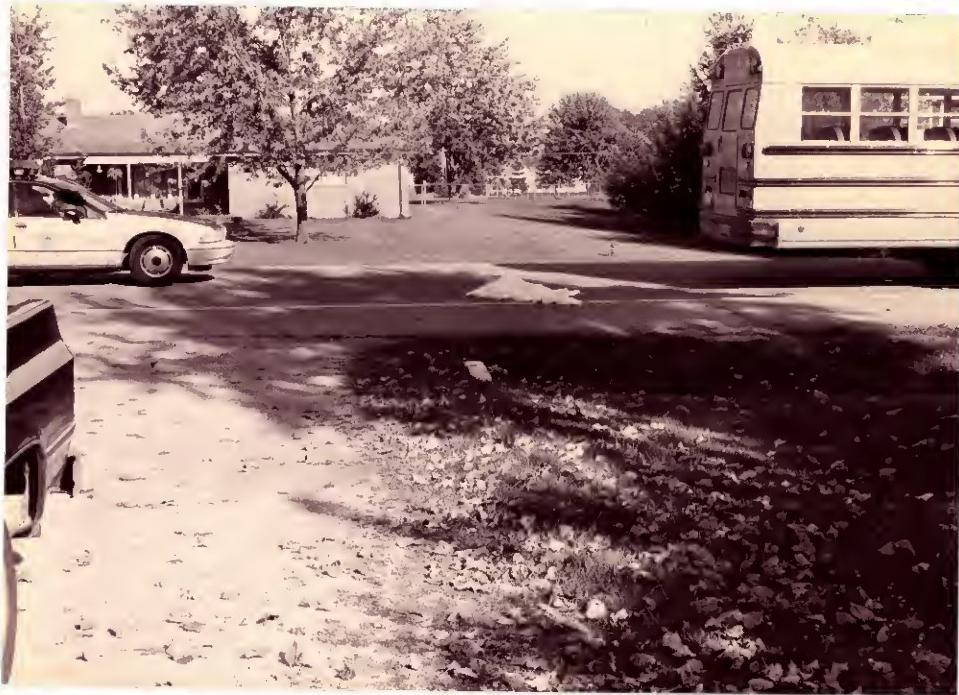
# 05 --

TRC/IU: 92-10, Task: 0085  
MCSD-Ped's path of travel

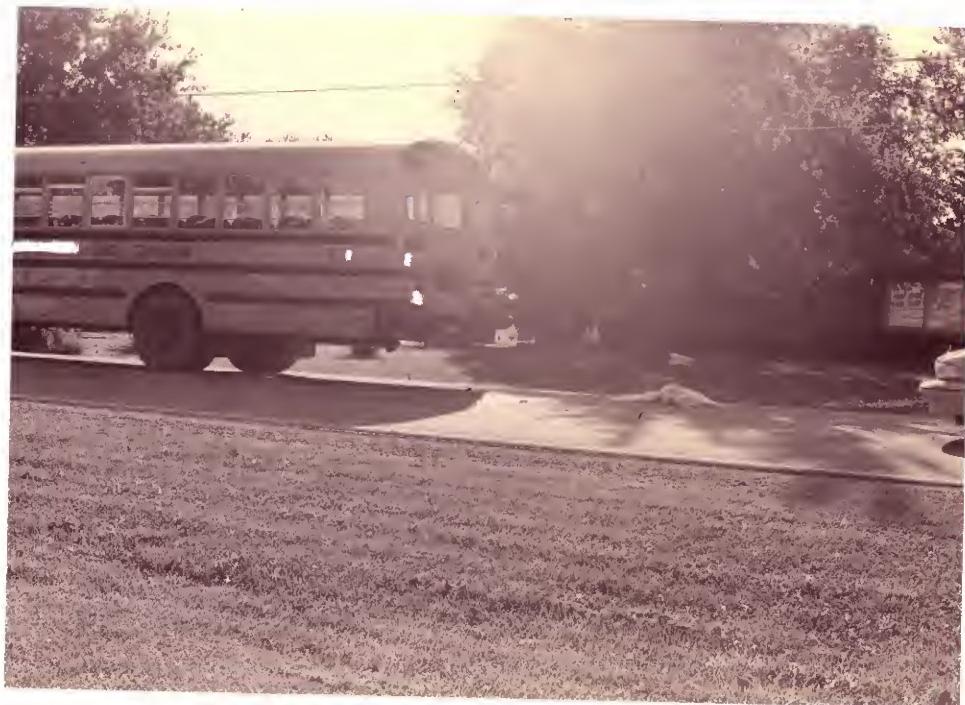
# 06 --

TRC/IU: 92-10, Task: 0085  
MCSD-Rear & left & victim

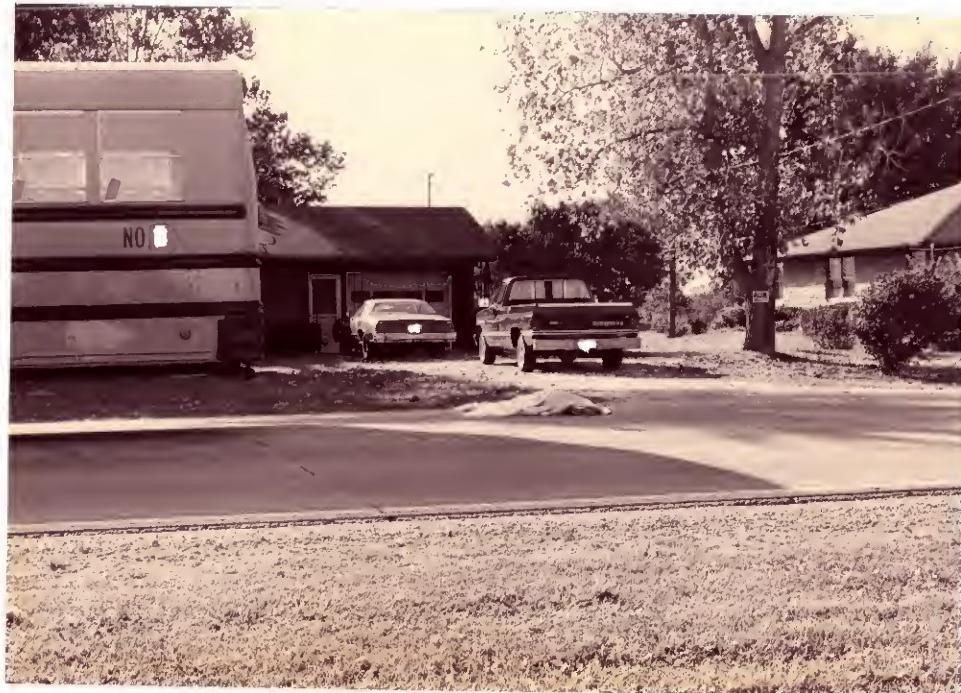
# 07 -- 1992

TRC/IU: 92-10, Task: 0085  
MCSD-Look back @ ped's path

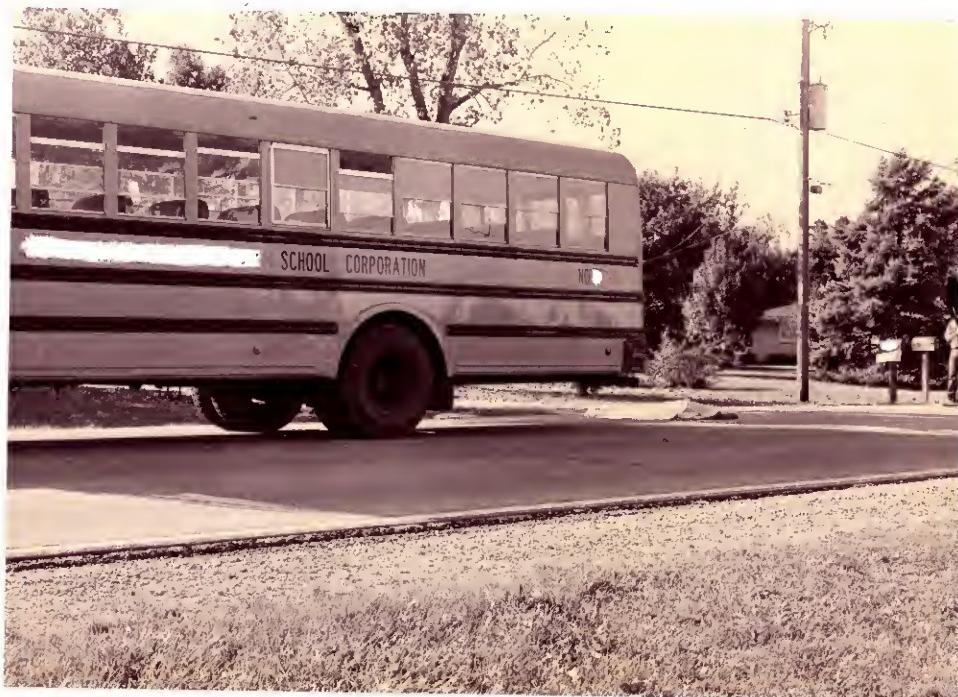
# 08 -- 1992

TRC/IU: 92-10, Task: 0085  
MCSD-Left side bus & victim

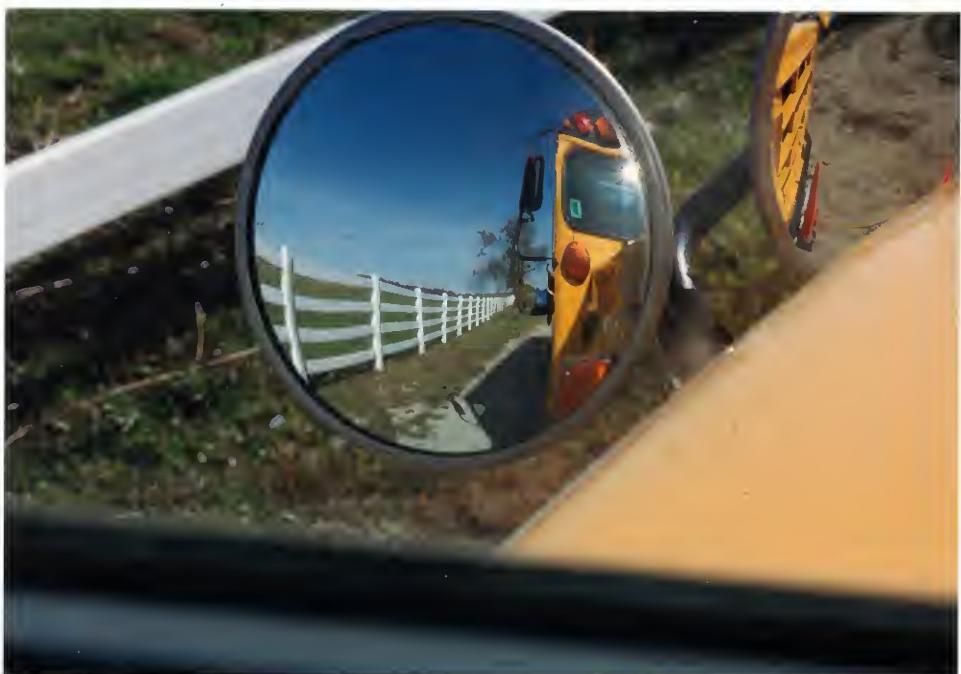
# 28 -

TRC/IU: 92-10, Task: 0085  
Closeup L side convex mirror

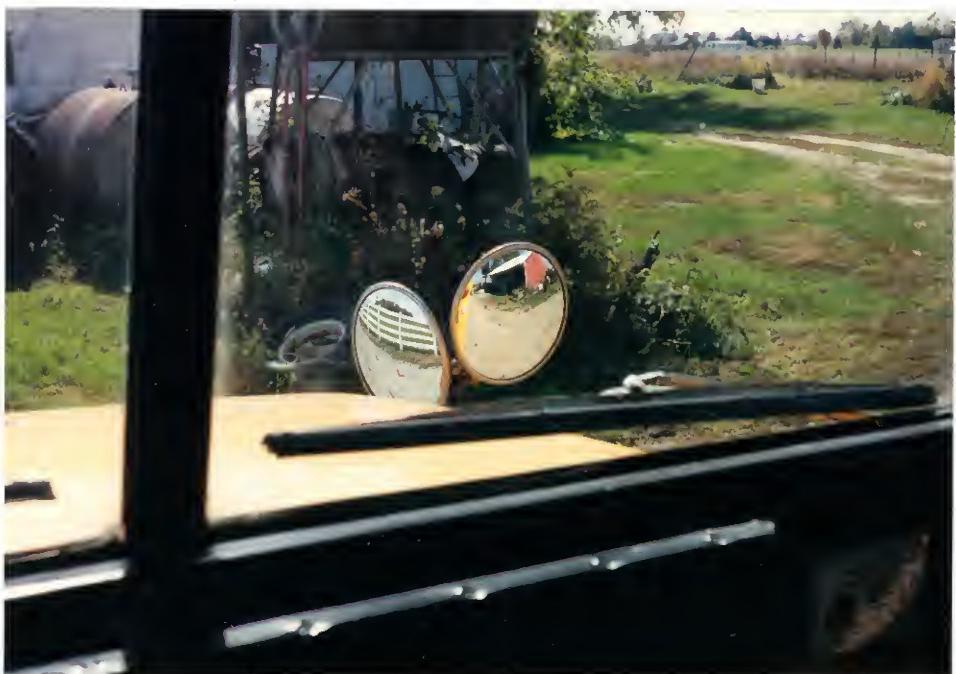
# 30 -- 1992

TRC/IU: 92-10, Task: 0085  
Right side convex mirrors

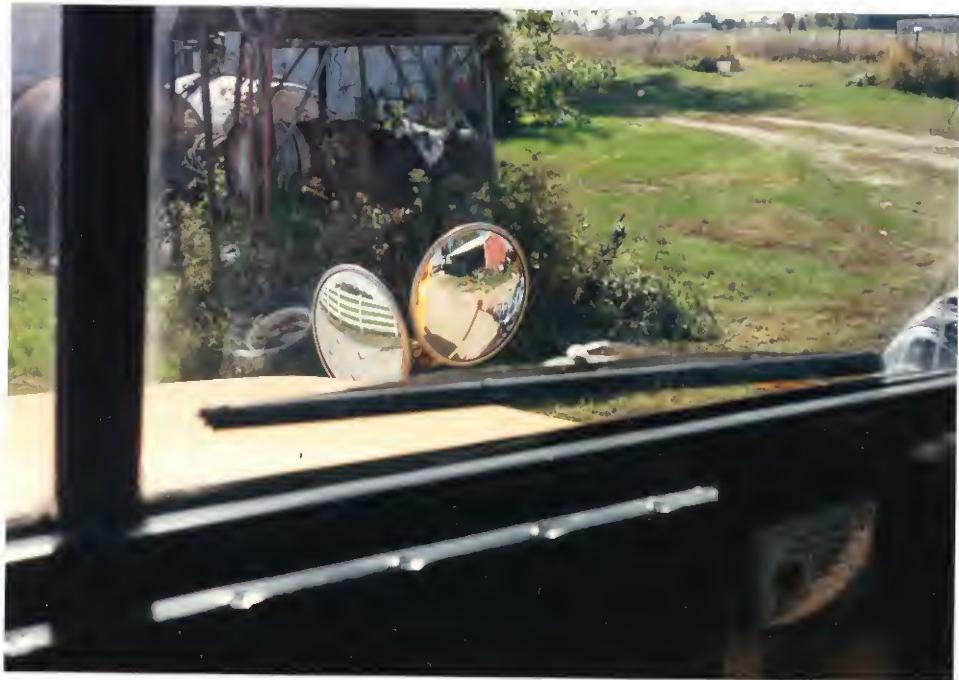
# 31 --

TRC/IU: 92-10, Task: 0085  
Cone K is not visible

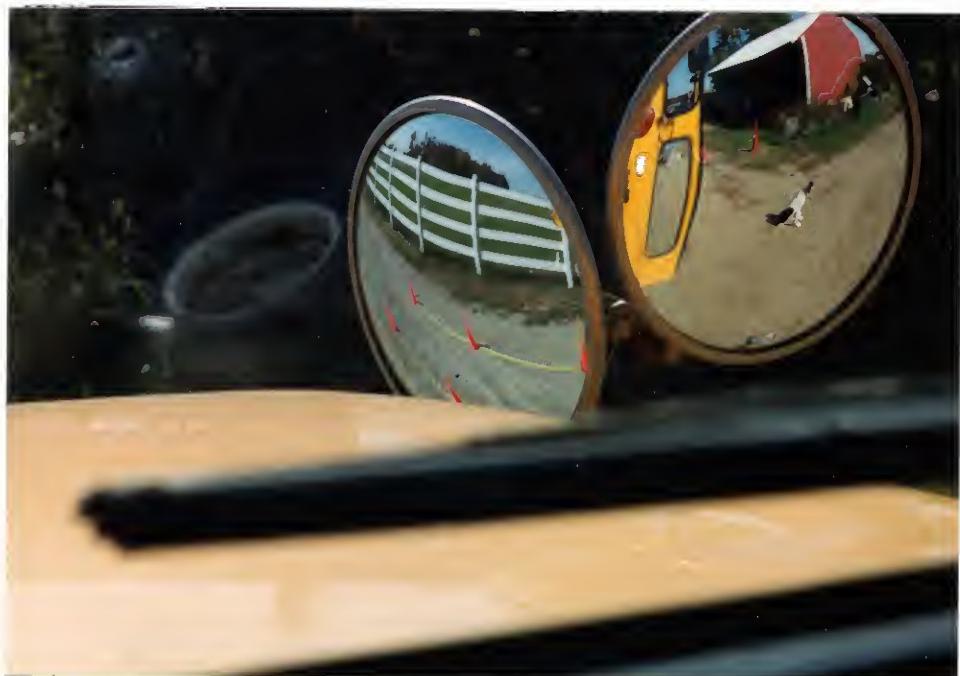
# 32 --

TRC/IU: 92-10, Task: 0085  
Closeup R crossview mirror

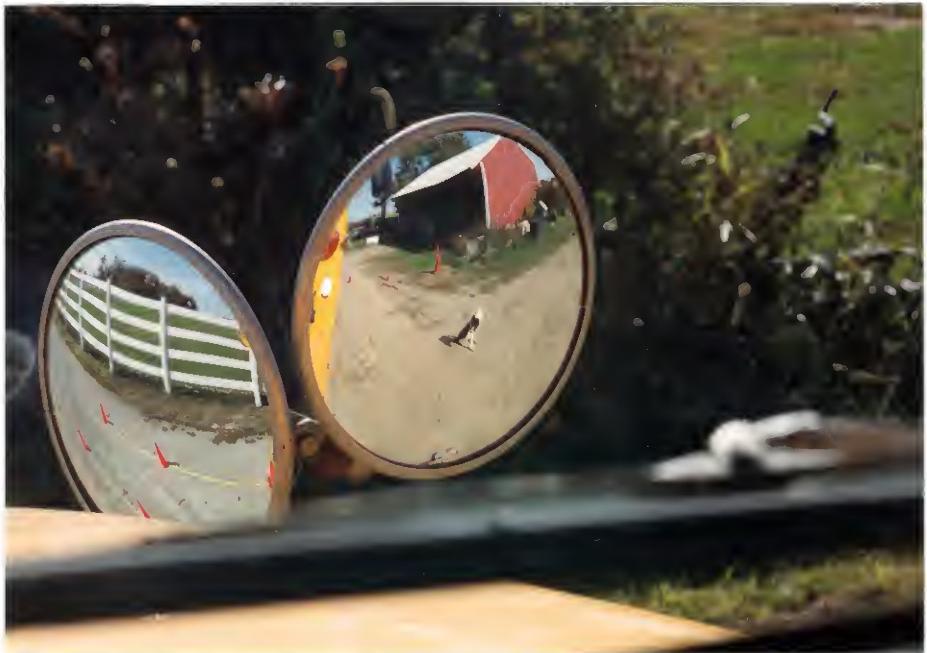
# 33 --

In our opinion, there are "blind spots" in this school bus driver's field-of-view. Of greatest importance in this fatal collision is the "blind spot" near Test Cylinder position H that is due to improper front-right, crossover, convex and front-left, crossover, convex mirror adjustments. There are also "blind spots" near Test Cylinder positions J (between the driver's window and left-front bumper corner) and K (i.e., between the right-side exit door and the right-front bumper corner). There is also a "blind spot" near Test Cylinder position L between the right side of the bus and the test cylinder that is due both to improper front-right, side, convex mirror and right, outside, rearview, unit magnification mirror adjustment.

TRC/IU: 92-10, Task: 0085  
Closeup R side convex mirror

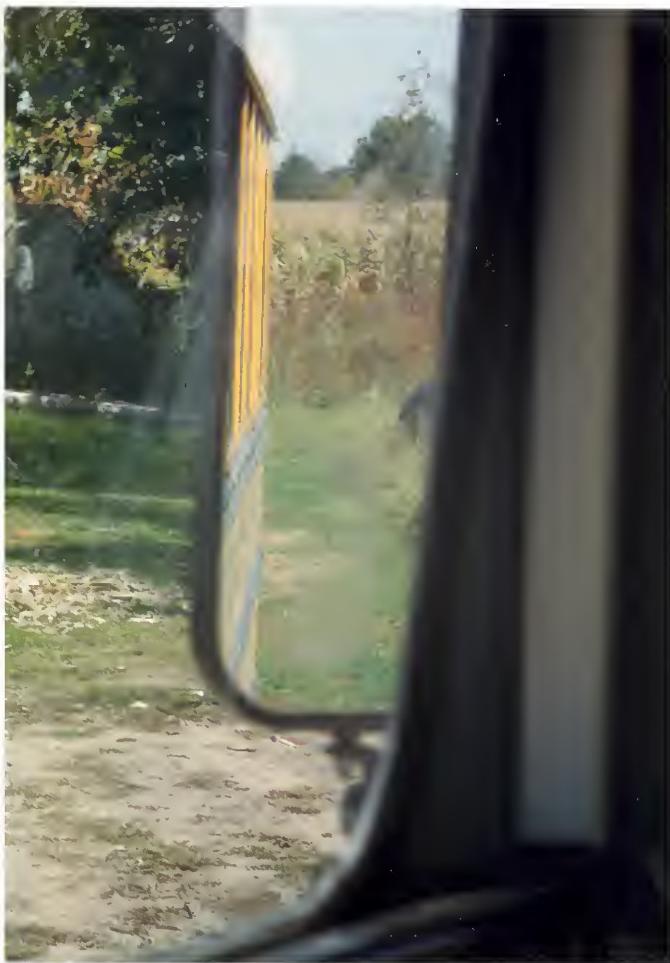
# 35 --

TRC/IU: 92-10, Task: 0085  
Closeup R outside RV mirror

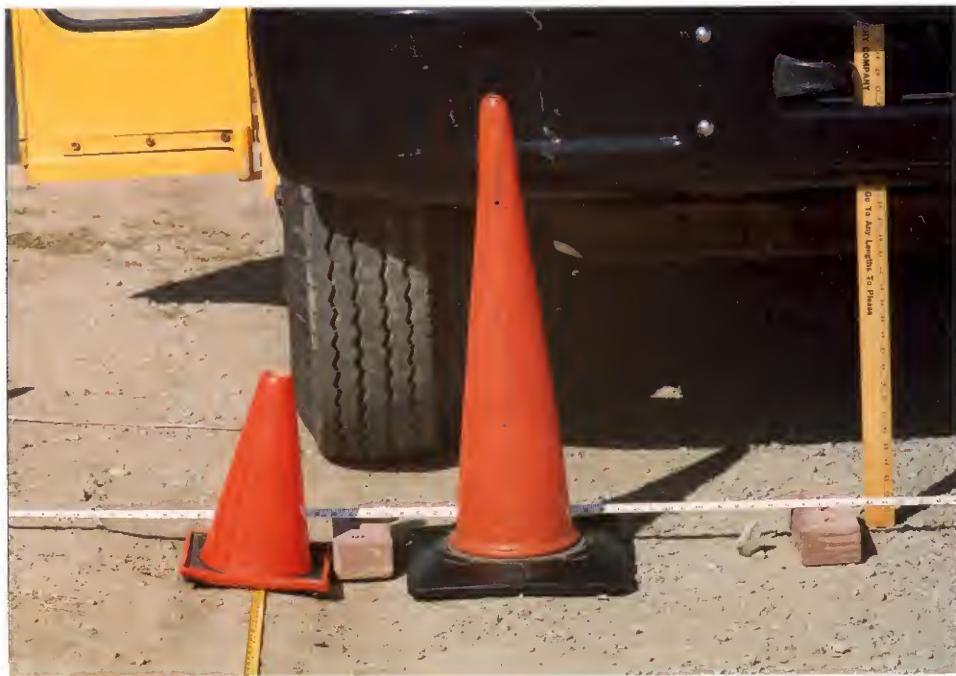
# 36 --

TRC/IU: 92-10, Task: 0085  
Cone representing pedestrian

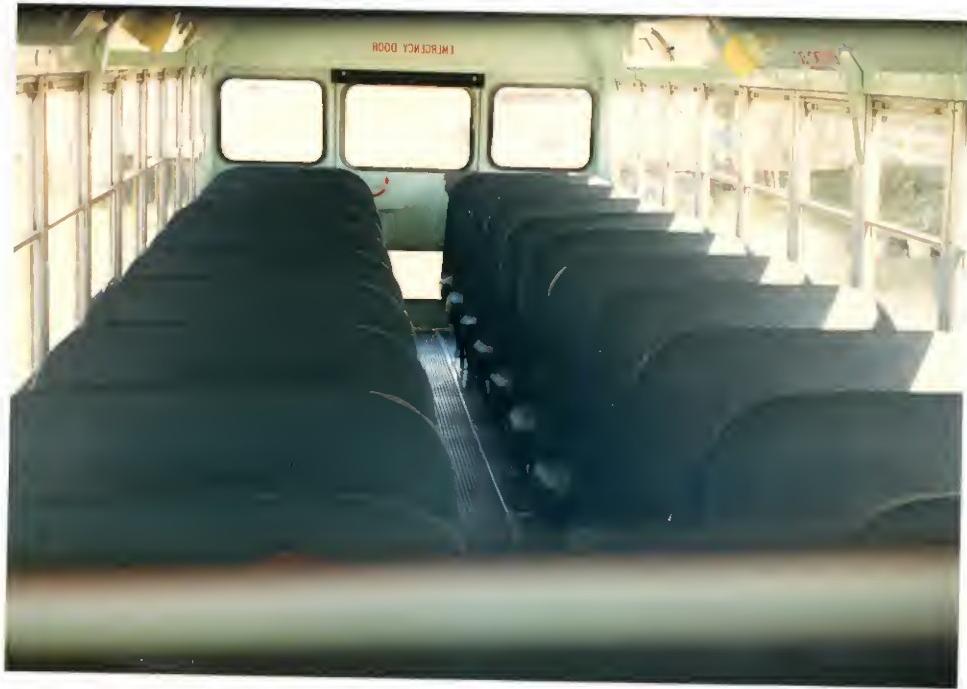
# 37 -- 1992

TRC/IU: 92-10, Task: 0085  
Inside rearview mirror

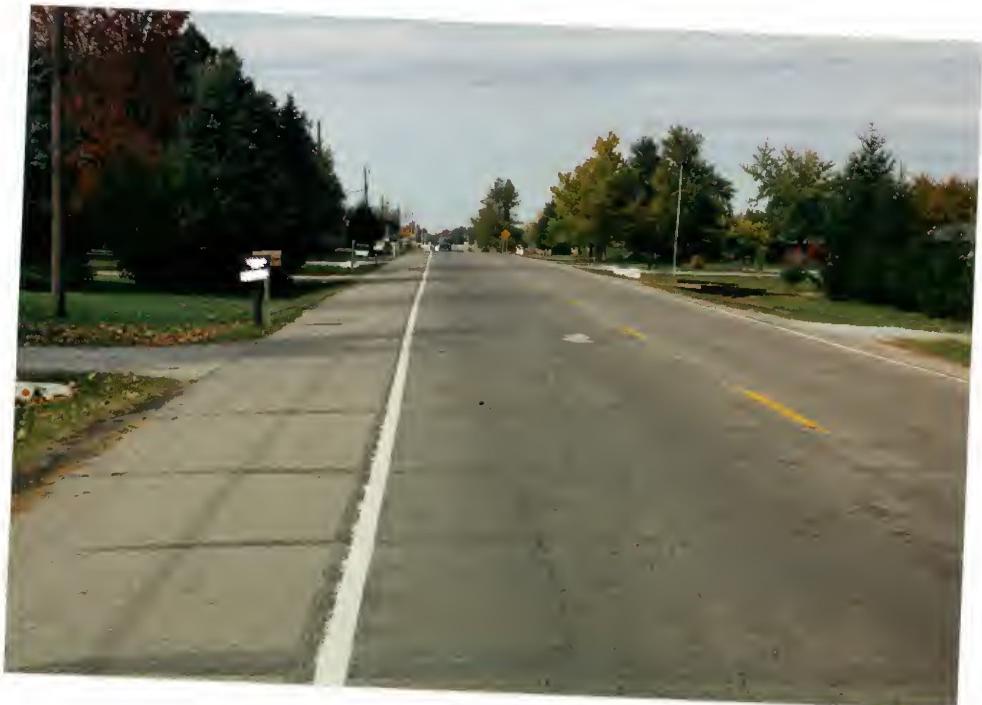
# 38 -- 1992

TRC/IU: 92-10, Task: 0085  
Lookback @ impact & approach

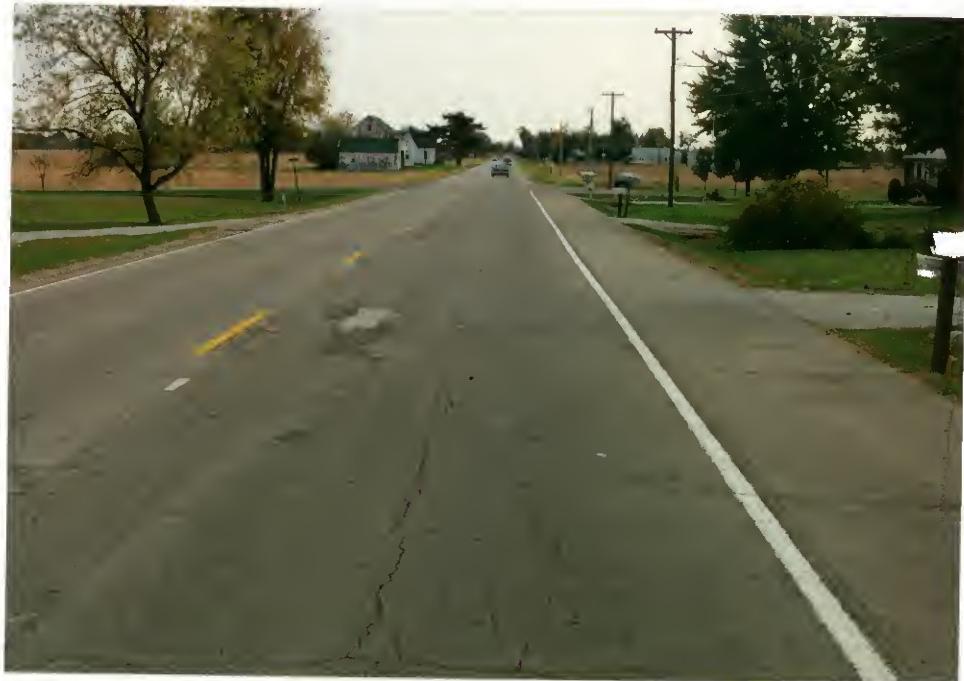
# 40 --

TRC/IU: 92-10, Task: 0085  
Impact @ far side driveway

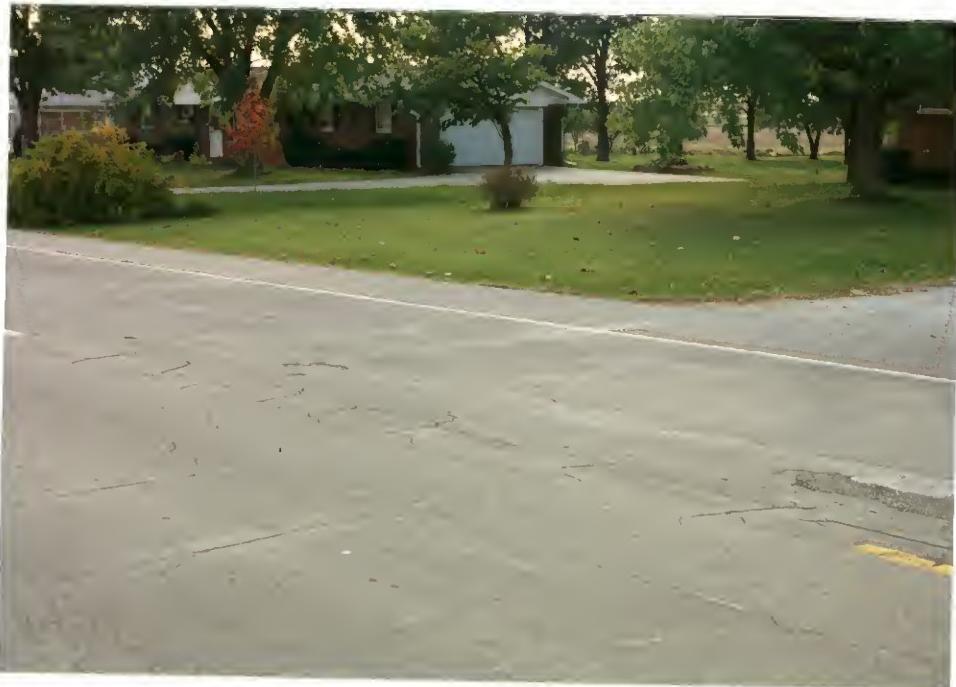
# 41 --

TRC/IU: 92-10, Task: 0085  
Driveway & impact looking SW
